DEPARTMENT OF TRANSPORTATION

Quality Assurance and Source Inspection

Contract #: 04-0120F4Cty: SF/ALA Rte: 80 PM: 13.2/13.9File #: 99.28**WELDING INSPECTION REPORT****Resident Engineer:** Casey, William**Address:** 333 Burma Road**City:** Oakland, CA 94607**Report No:** WIR-026285**Date Inspected:** 15-Sep-2011**Project Name:** SAS Superstructure**OSM Arrival Time:** 1100**Prime Contractor:** American Bridge/Fluor Enterprises, a JV**OSM Departure Time:** 1930**Contractor:** Watson Bowman Associates**Location:** Buffalo, NY**CWI Name:** John Miller**CWI Present:** Yes No**Inspected CWI report:** Yes No N/A**Rod Oven in Use:** Yes No N/A**Electrode to specification:** Yes No N/A**Weld Procedures Followed:** Yes No N/A**Qualified Welders:** Yes No N/A**Verified Joint Fit-up:** Yes No N/A**Approved Drawings:** Yes No N/A**Approved WPS:** Yes No N/A**Delayed / Cancelled:** Yes No N/A**Bridge No:** 34-0006**Component:** Hinge A Expansion joint**Summary of Items Observed:**

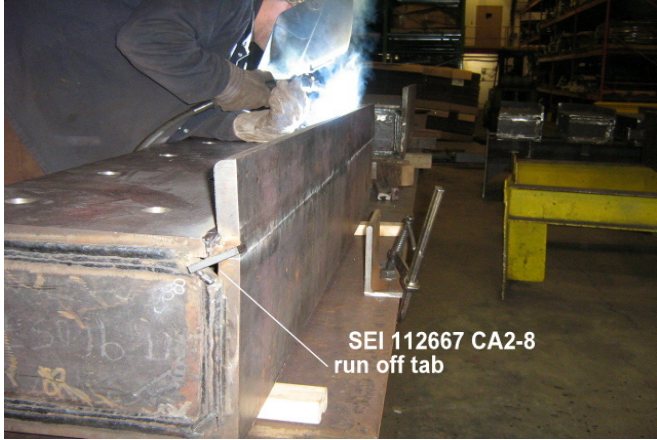
This QAI observed certified welder Jayson Gray (welder ID#J) using the FCAW process (dual shield, 100% CO₂), filler metal TM-811N1, to weld CJP welds on the SEI112667 CA2-8 Channel Assembly (1 of 24). The weld joint in-process was the top plate to back plate CJP groove weld. All welding was being performed in the 1G position. The run off tab does not duplicate the joint detail. Reference attached photo.
